NBS BUILDING SCIENCE SERIES 94

Investigation of the Skelton House Collapse
in Fairfax County, Virginia

Investigation of the Skyline Plaza Collapse in Fairfax County, Virginia

NBS Building Research Institute, Inc. 34
Edgar V. Leyendecker and S. George Fattal

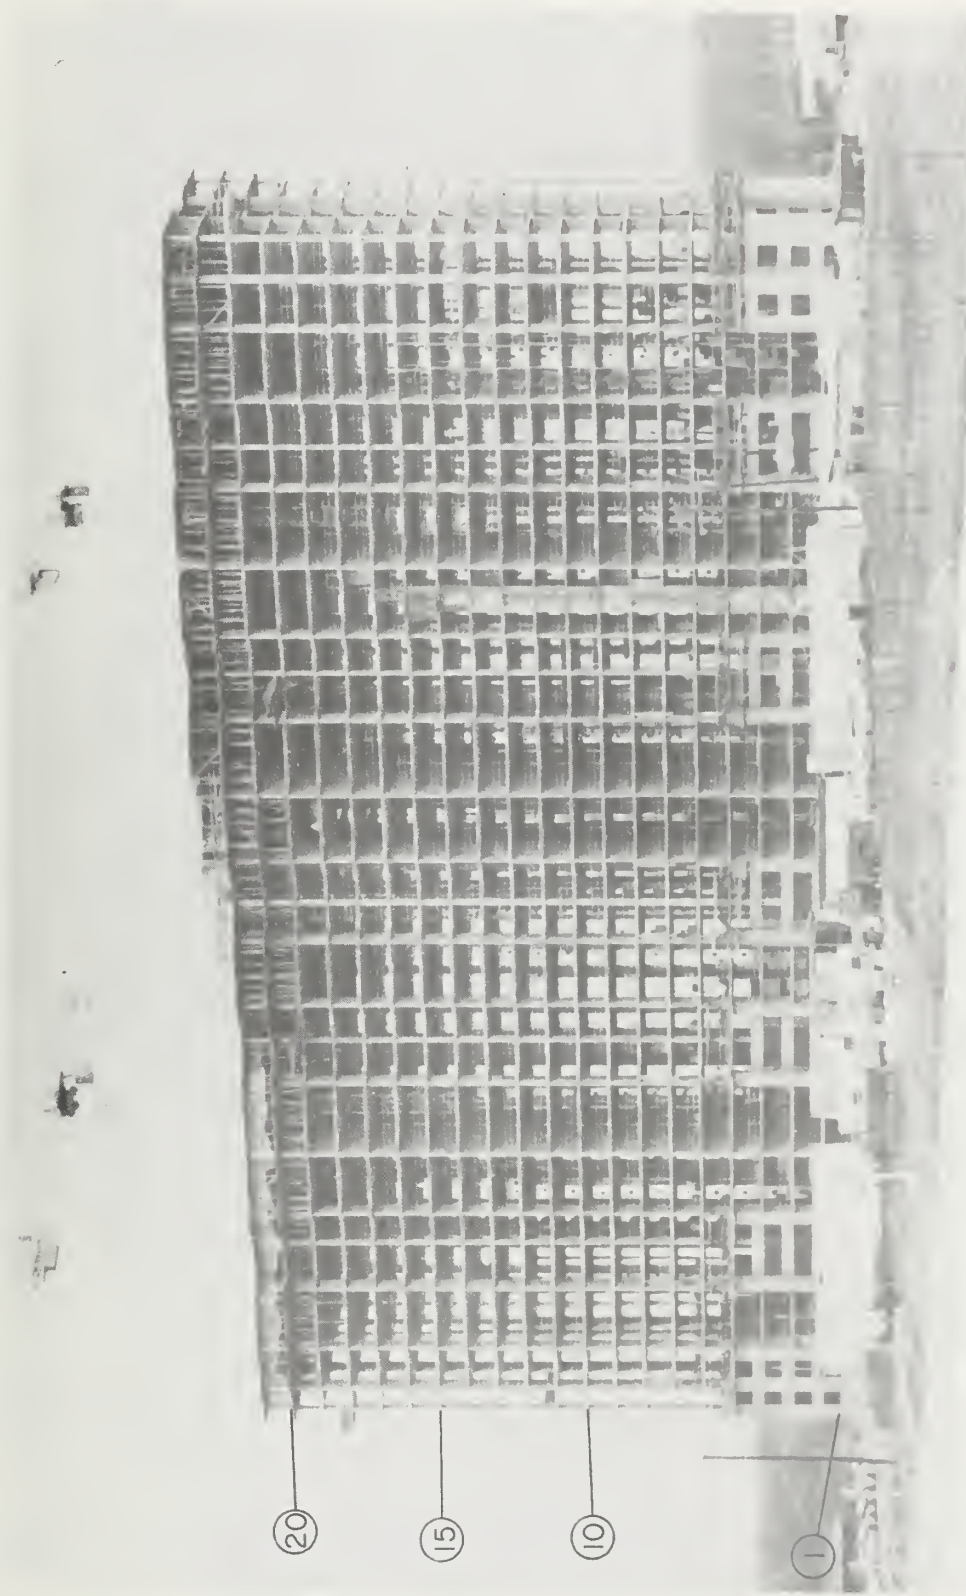
The date of the photograph (reported as February 11 or 18) can be checked by looking at figures 2.39, 2.42, and 2.2. Close examination indicates that none of the 22nd floor had been cast at the time of the photograph (openings can be seen in the slab forms). Since figure 2.2 indicates that section 1 on the 22nd floor was cast on February 14, it is established that the photograph was taken before that date. Due to the construction progress shown in the figure it can be stated that section 2 of the 21st floor which was cast February 6 (figure 2.2) was in place. Based on this evidence it appears that the photograph was taken between February 6 and February 14.

Figure 2.39 Appearance of construction in February some time after figure 2.36, looking south.

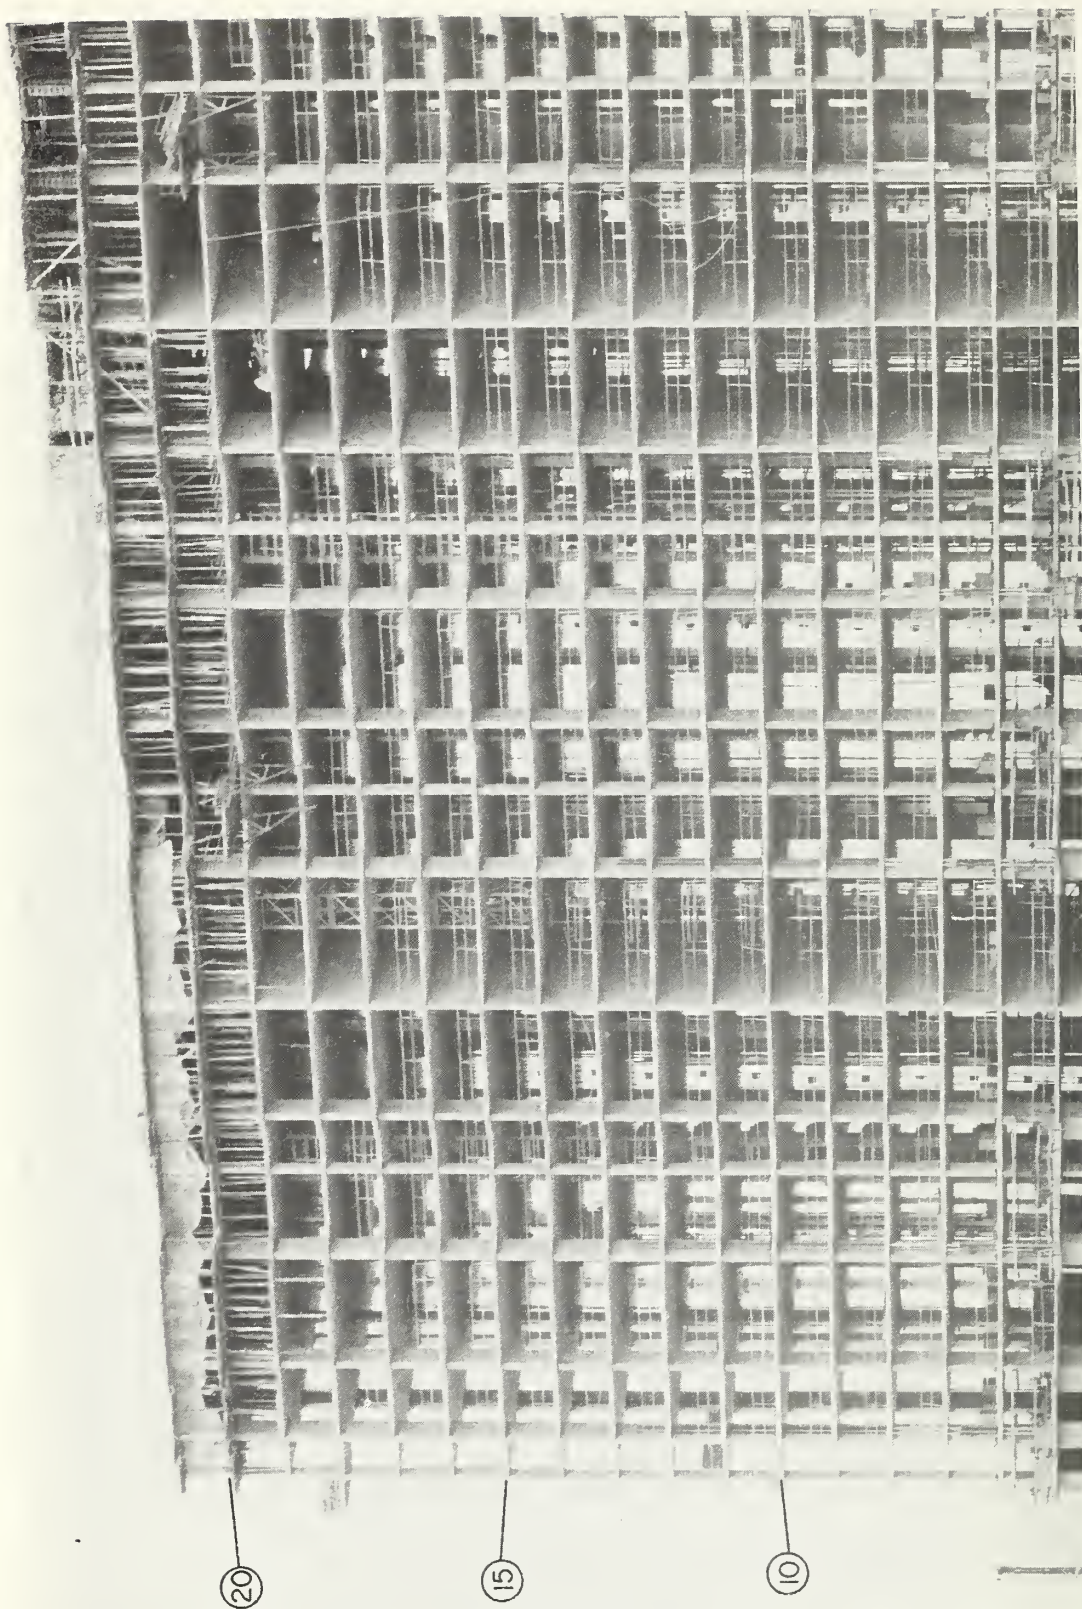
Although the forms are in place for sections 3 and 4 of the 21st floor, it cannot be positively stated that they have been cast. Therefore, on the basis of these photographs (figures 2.39 through 2.42) it cannot be conclusively stated that the crane which was raised on February 7 was based on the 14th floor.

Figure 2.42 Closeup view showing crane no. 2 base support and shoring under crane.

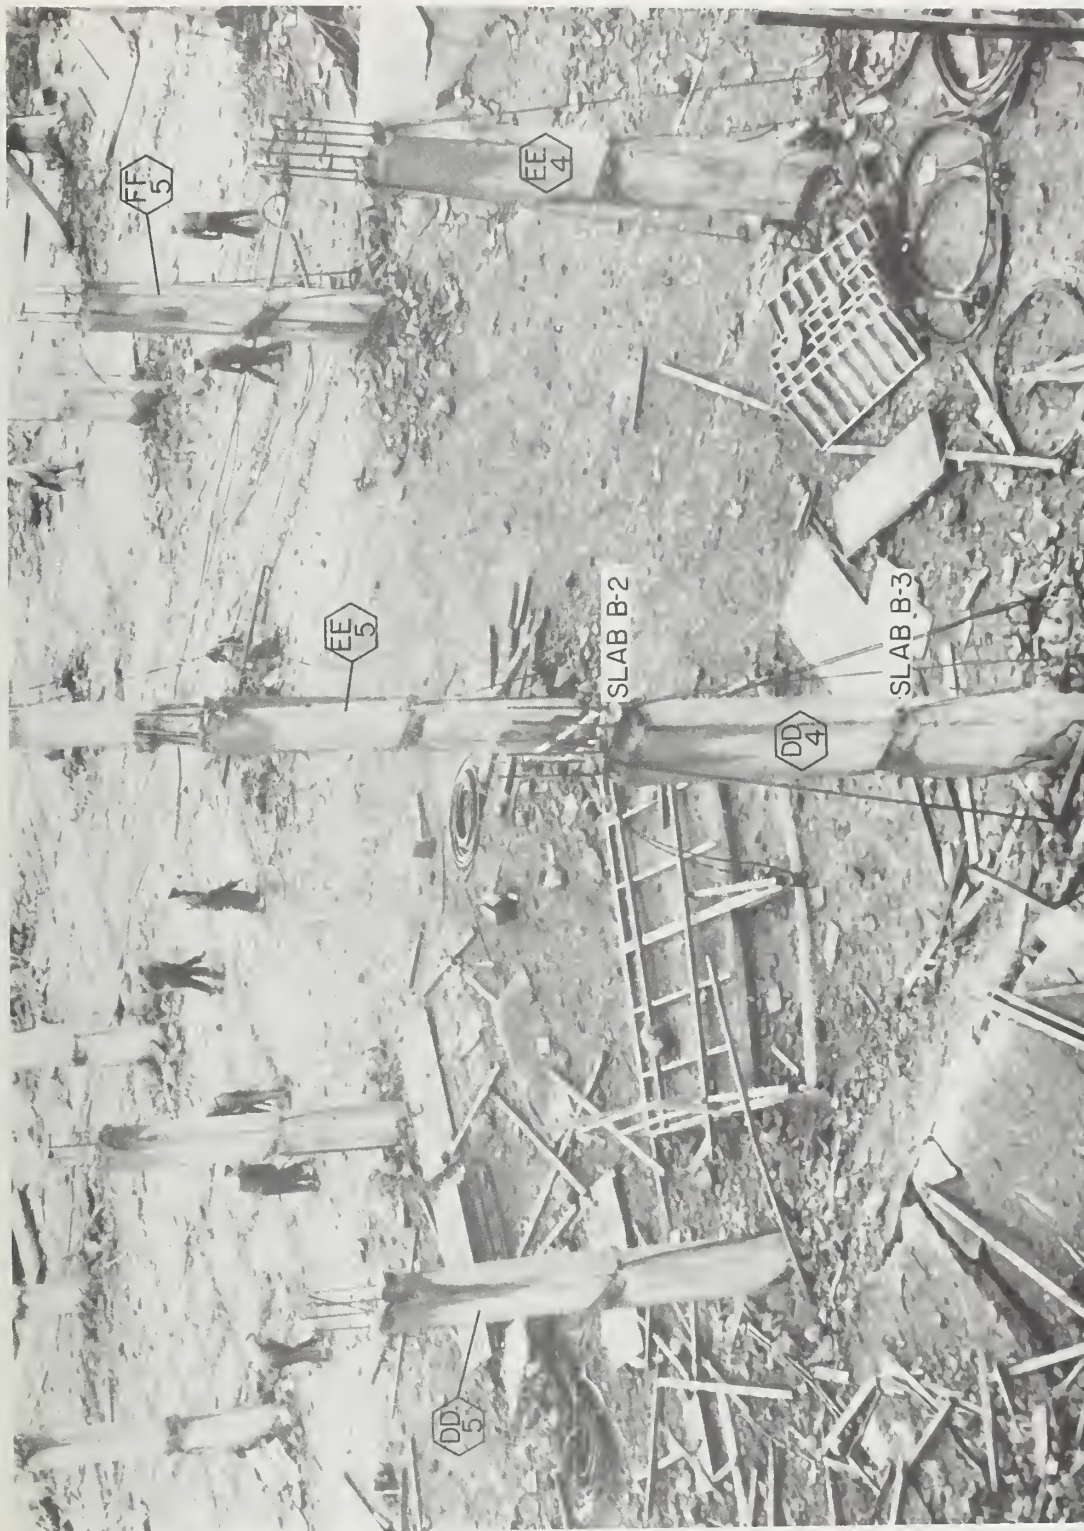
The locations of slabs B-3 and B-2 are shown in figure 2.44 on column DD-4. Note the virtual lack of shear cones at the slab levels on most of the columns in that figure.

Figure 2.44 Closeup view of columns in figure 2.43.

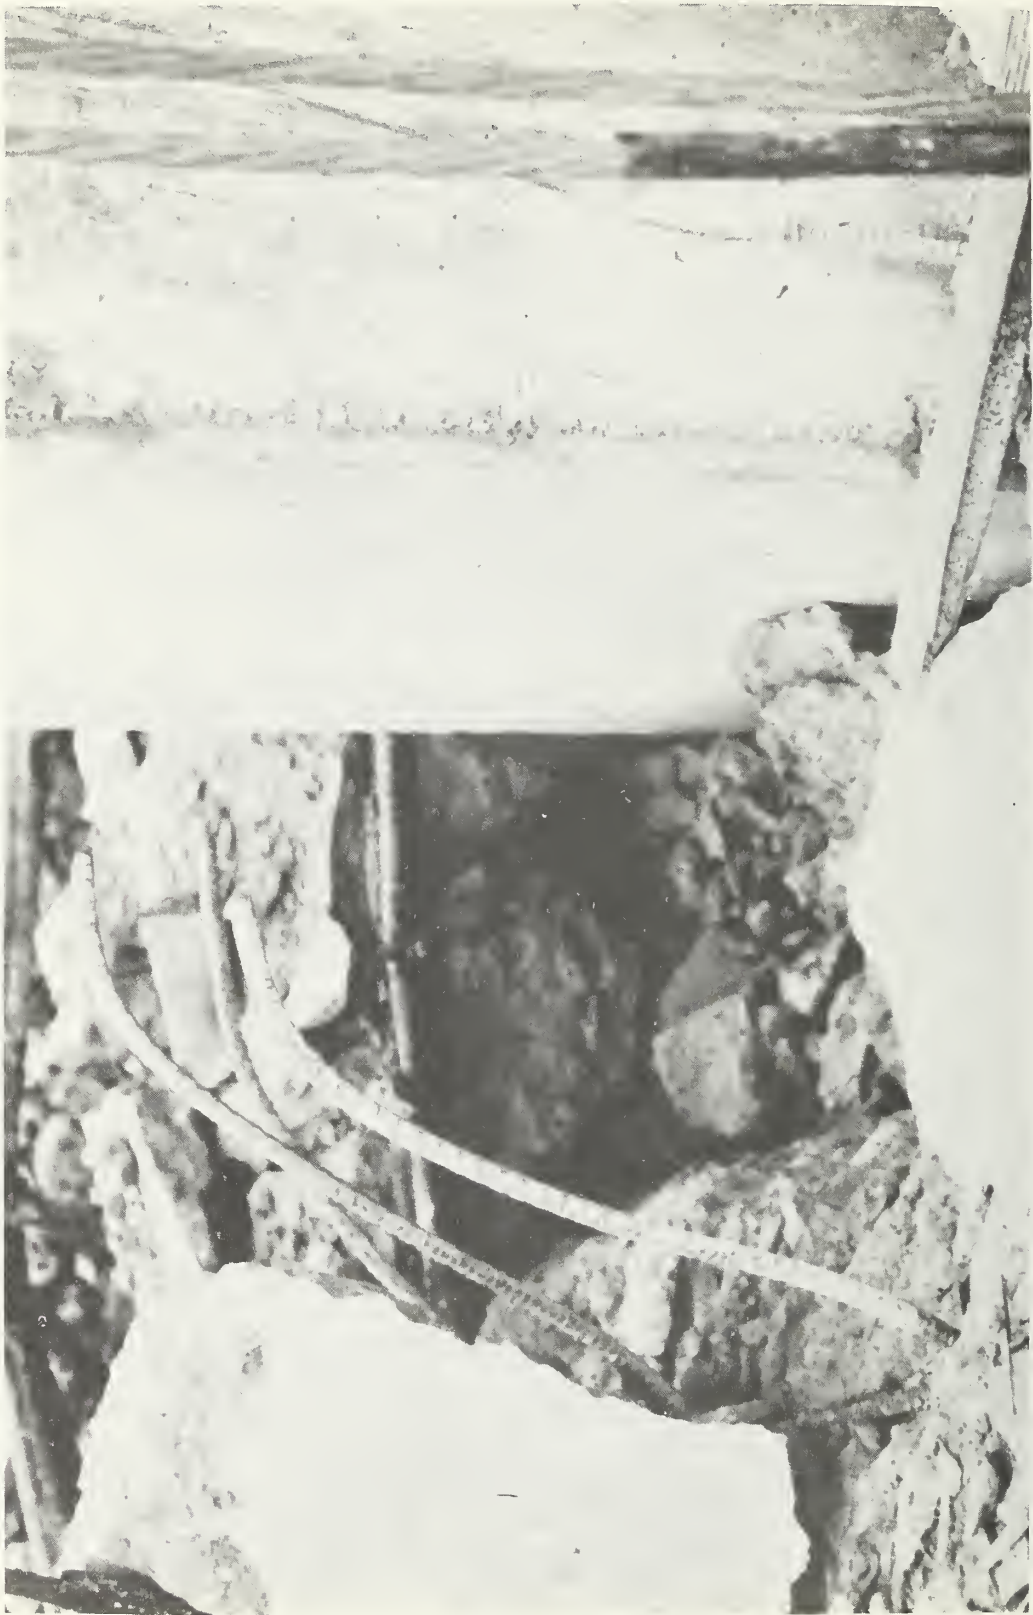
Column KK-6 may be seen in figure 2.47. Once again the shear cone usually associated with a slab punching failure is not visible in the photograph. Note the ruptured reinforcing bars at the base of the column. These are shown more clearly in figure 2.48 (but not for column KK-6).

Figure 2.48 Typical view of column base.

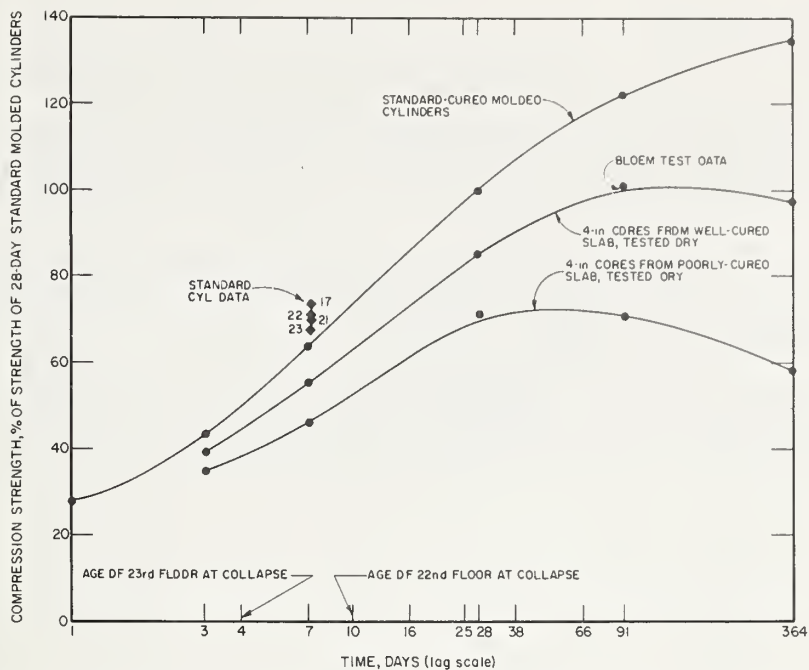
Figure 3.3 Strength measures for concrete cores and cylinders.

Estimates were obtained for a range of standard 6-in diameter cylinders by converting from the age at time of test to 28-day 6-in cylinder strength using the curves of figure 3.3. The calculations rounded to the nearest 5 psi follow:

The cores are used as a measure of in-situ strength. The Klieger data require the use of 28-day strengths. The core strengths for the 22nd and 23rd floors are converted to 28-day strengths by using figure 3.3. The basic core data are multiplied by the ratio of the 28-day fraction to the fraction at the date tested. These calculations rounded to the nearest 10 psi follow:

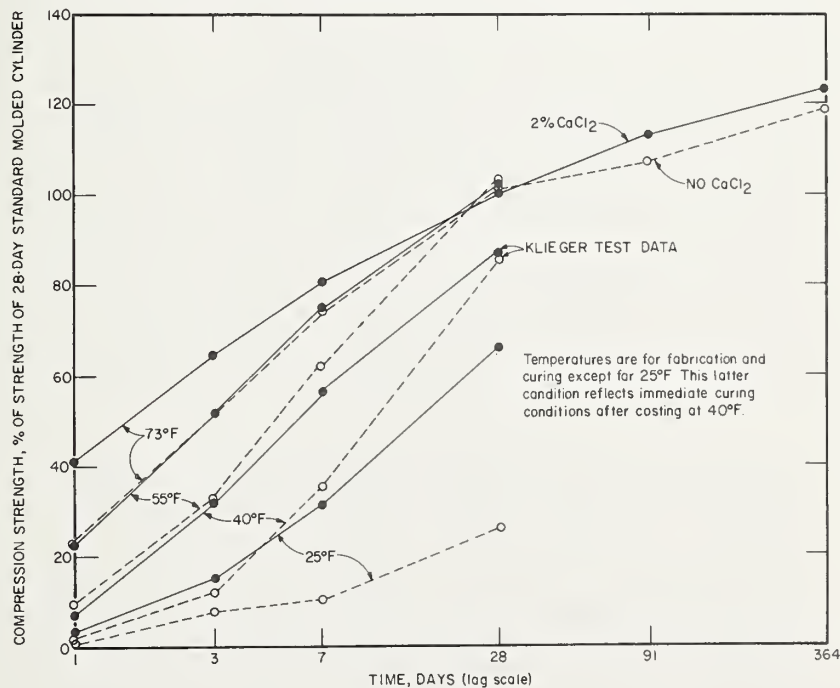
Figure 3.4 Development of concrete strength under various curing temperatures.

A set of curves have been drawn in figure 3.4 from data obtained by Klieger [14]. These curves, although obtained from normal weight aggregate concrete, indicate the effect of curing temperatures and 2 percent calcium chloride on concrete compressive strength development. The 73°F curing curve without calcium chloride represents strength gain under standard conditions. Note the accelerating effect on strength development of 2 percent calcium chloride. For example, a concrete cured at 55°F with 2 percent calcium chloride is equivalent in strength (during the first 28 days) to the same concrete cured at 73°F. Although not used in all floors, 2 percent calcium chloride was used for the 17th and 21st through 24th floor slabs.

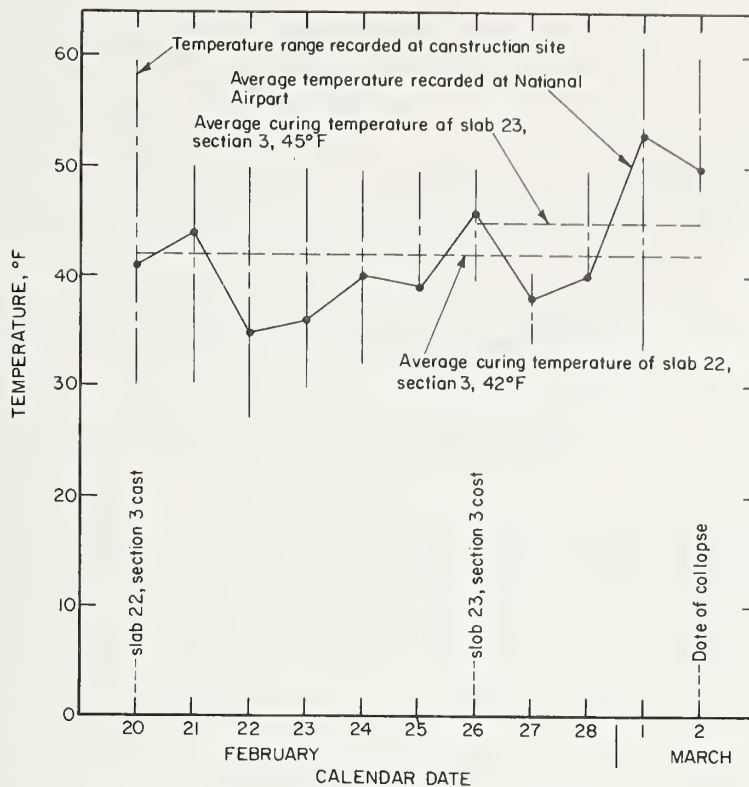
Figure 3.5 Temperature history for section 3 on 22nd and 23rd floor slabs.

In order to convert these strengths into estimates at the time of collapse the curing temperature should be considered. The average temperature history has been shown in figure 3.5 (enlarged from figure 2.3). The average air temperature was 42°F for the 22nd floor and 45° for the 23rd floor (temperatures as recorded at National Airport). Estimates of strength using the Klieger data for 2 percent calcium chloride in figure 3.4 (and interpolating between temperature curves) yields the following results rounded to the nearest 10 psi:

A total of 12 reinforcing bars were tested, 6 of these were removed from floor slabs of the collapsed section of the building and 6 were tested from unused reinforcement steel at the construction site. The results of these tests are shown in figure 3.6 [17].

The structural engineer generally called for reinforcing steel with a 60,000 psi yield point and meeting the requirements of ASTM A-615. The steel tested satisfies the requirements of that specification.

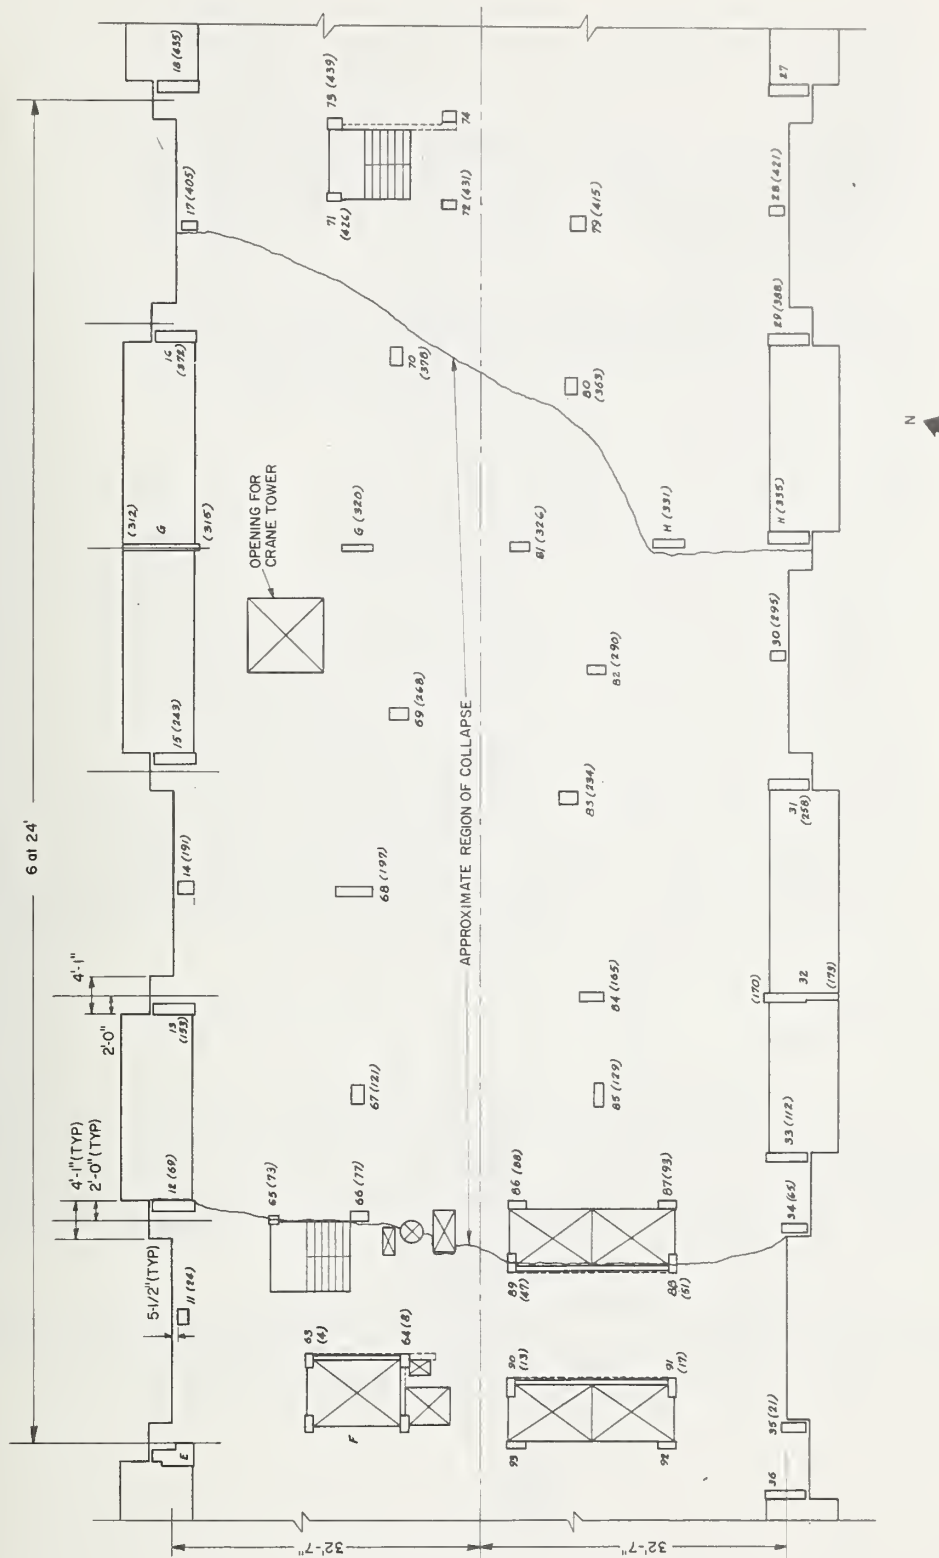
Figure 4.1 Plan of floor slab at 22nd and 23rd floors showing approximate area of collapse.

Three finite element analyses were made for the slab assembly in the region of collapse. The approximate area of collapse is shown in figure 4.1. All three analyses were based on the grid model shown in figure 4.2.

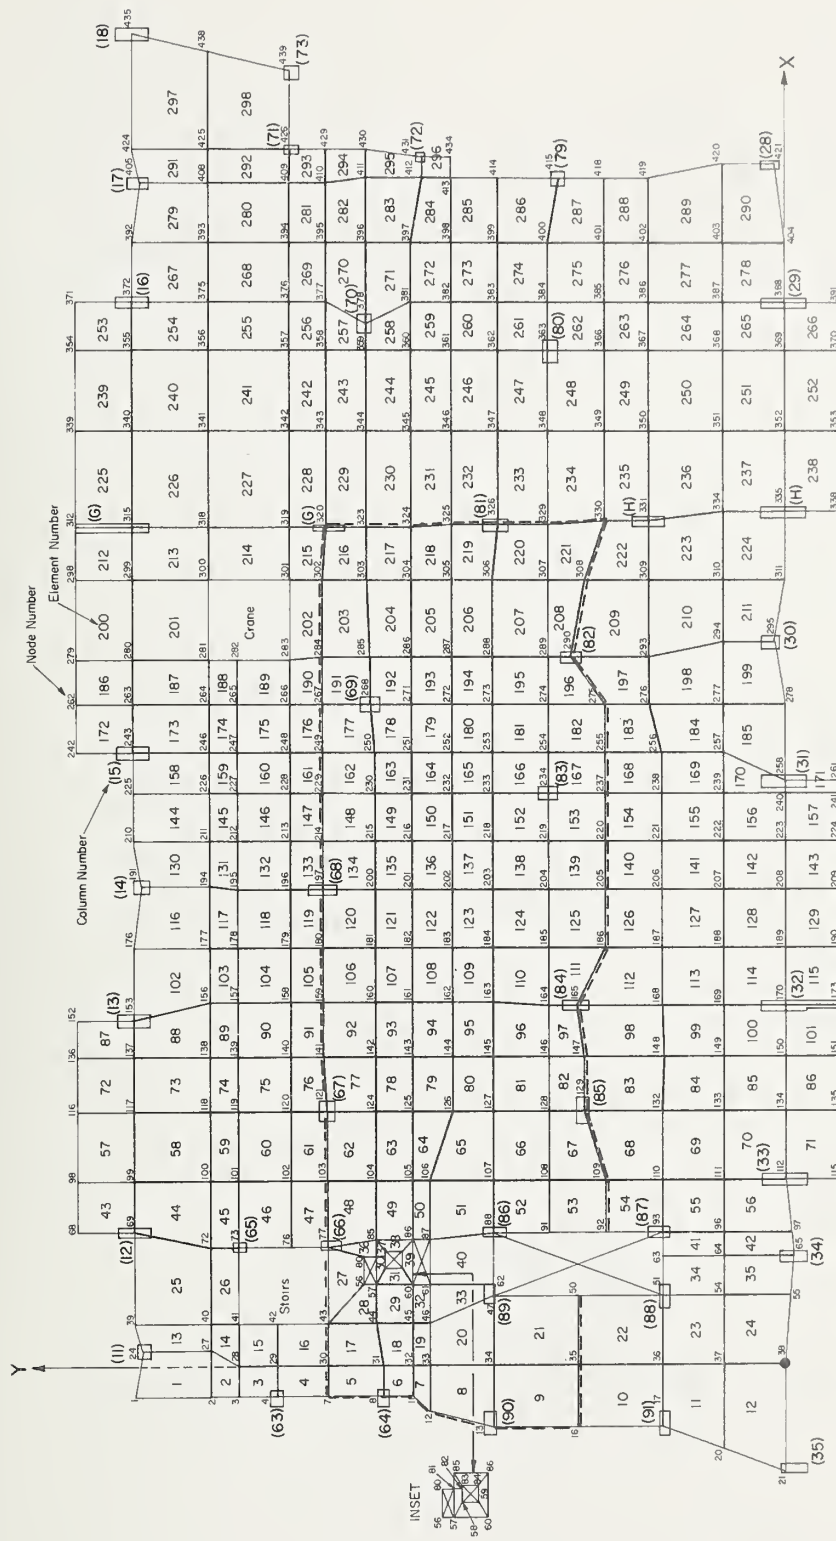
Figure 4.2 Finite element grid for slab analysis.

The grid layout in figure 4.2 is different from the slab in the contract drawings in certain aspects. The balcony slabs were assumed extending to the centerlines of the end columns. Likewise the boundary of the slab at north and south fascias between balconies was assumed extending to the centerlines of the flanking columns, eliminating, in effect, the stepped portion of the slab between a balcony and an adjacent fascia. Wherever possible, rectangular or square plate elements were used to construct the grid. In order to make column centroids coincident with nodal points of the grid a few trapezoidal plate elements were also introduced. By using a finer mesh one could develop a model which would more precisely represent the actual assembly. However, such a refinement is not justified because it would not significantly affect the results [7A].

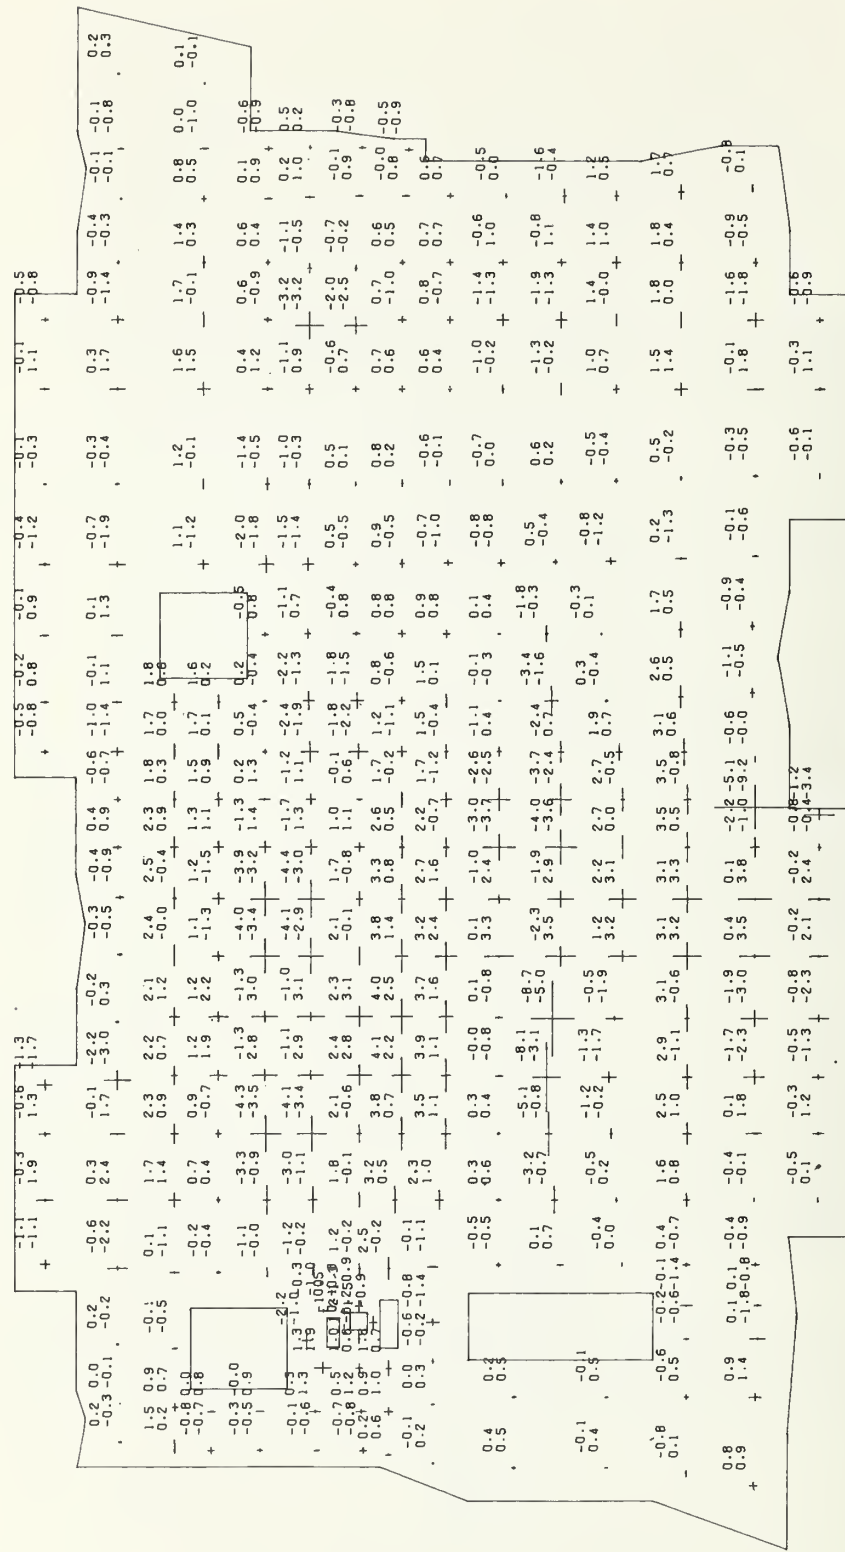
Figure 4.3 Internal moments in slab-case 1.

Figures 4.3 through 4.5 show the analytical results for cases 1 through 3. Moments M_x (rotation about x-axis) and M_y (rotation about y-axis) are designated by x horizontal and vertical lines, y respectively. They are shown plotted in pairs (and approximately to scale) at the centroids of slab elements. The numerical entries are moment magnitudes at the centroids and are expressed in units of foot-kips per linear foot of slab. Moments producing compression in the top of the slab are positive.

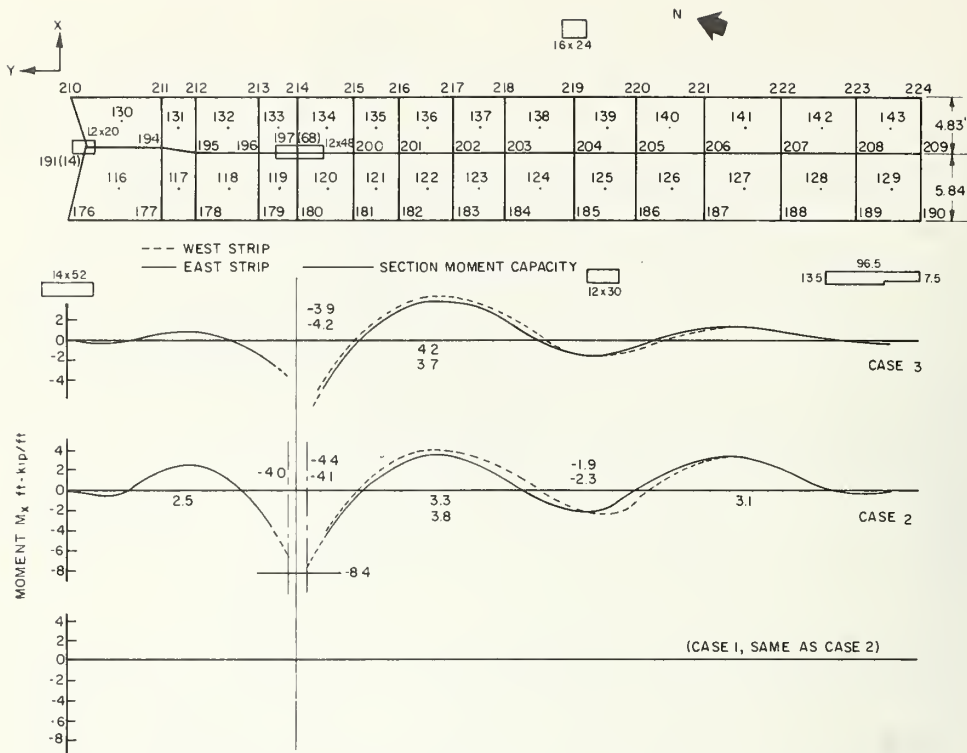
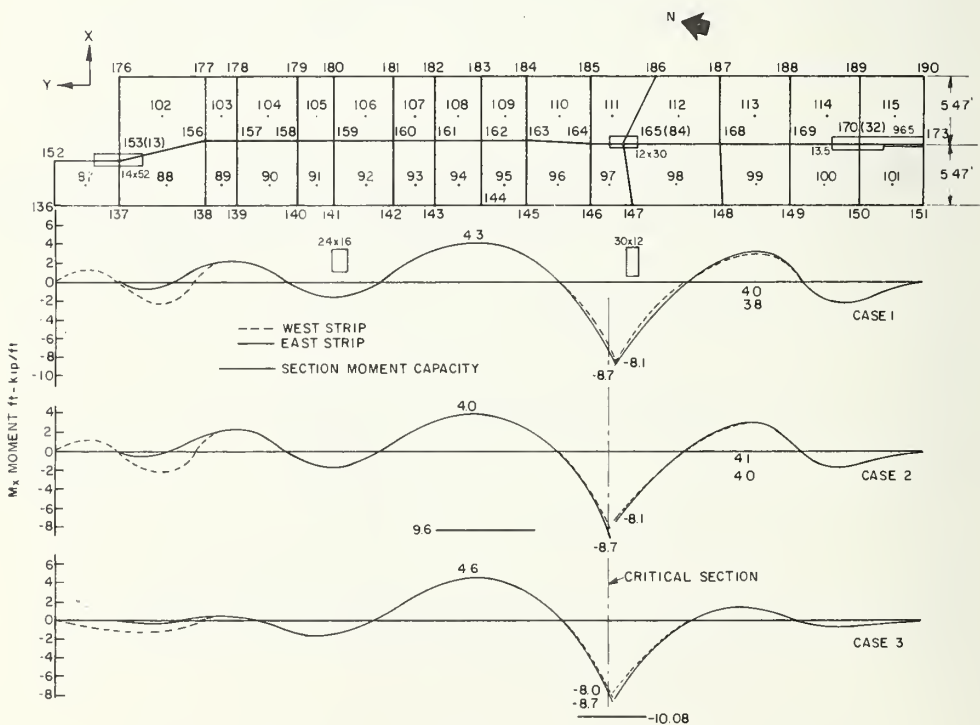
Figure 4.8 Moments in column strip 191-197.

Figures 4.6 through 4.9 show moment diagrams developed for column strips taken from the grid of figure 4.2. These strips were investigated for their adequacy to resist moments obtained by analysis. Negative moments were investigated at the face of the columns according to ACI 318-71.

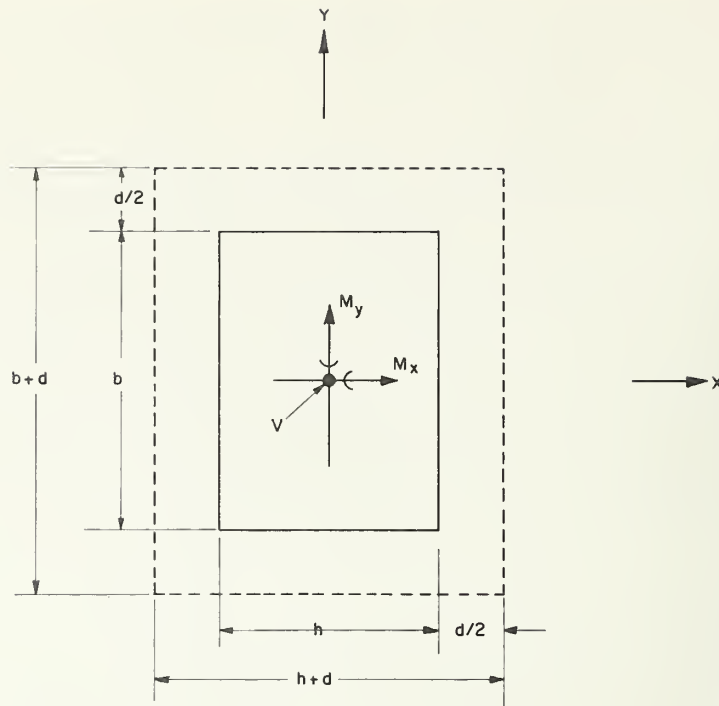
Figure 4.10 Typical rectangular column showing critical section for shear.

The slab was also investigated at column locations for its adequacy in shear. Shearing stresses were determined following the procedure described in section 11.13.2 of the commentary to the ACI 318-71 code. The applicable equations are given below for convenience. Figure 4.10 shows the critical section for shear around the periphery of a rectangular column and other parameters used in the following equations:
